Water management in Ontario

Ontario
Water Resources
Commission

Preliminary Evaluation of Streamflow Gauging Stations in the Venison Creek Basin

WATER RESOURCES
PAPER 3

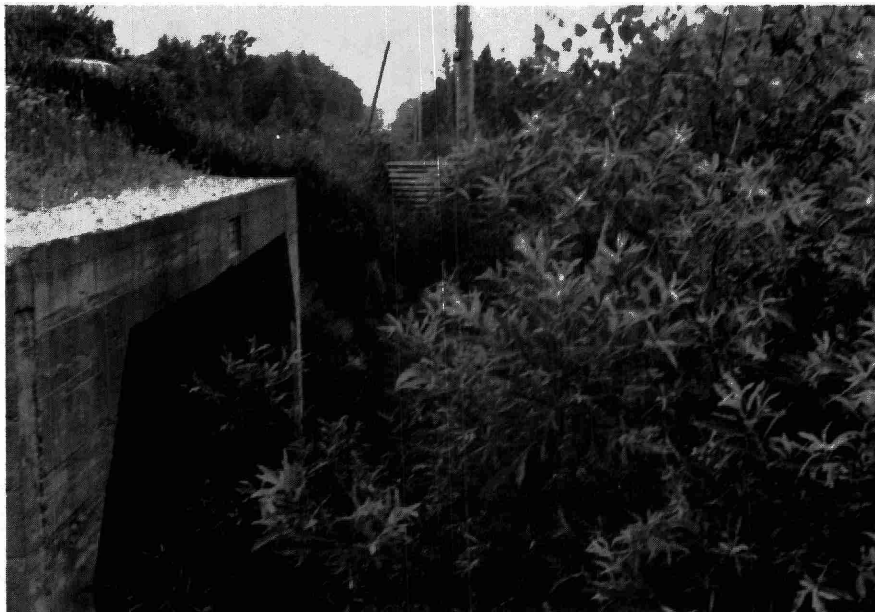
Station 2 GC-9 with the shelter and recorder removed.

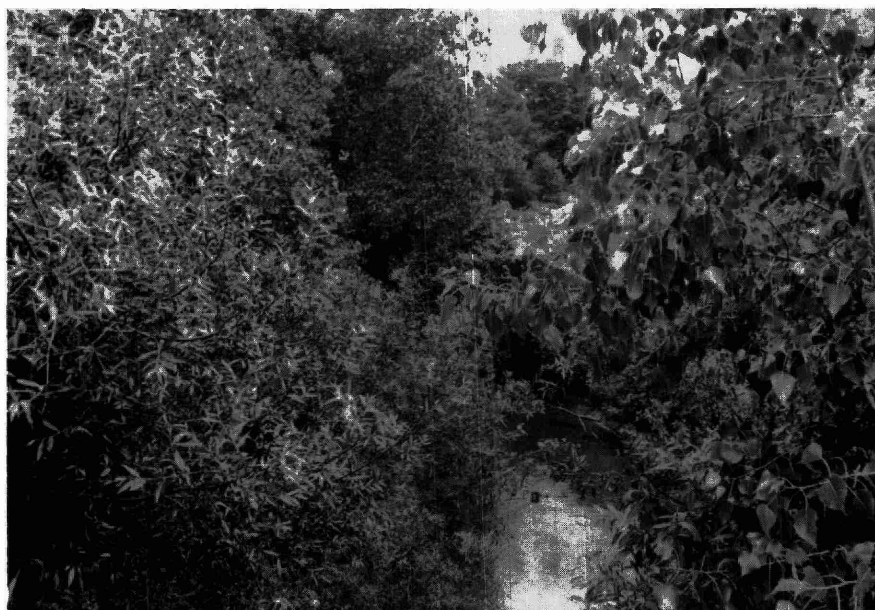
Looking upstream from the end of the culvert. The pond is almost entirely hidden under the abundant vegetative growth.

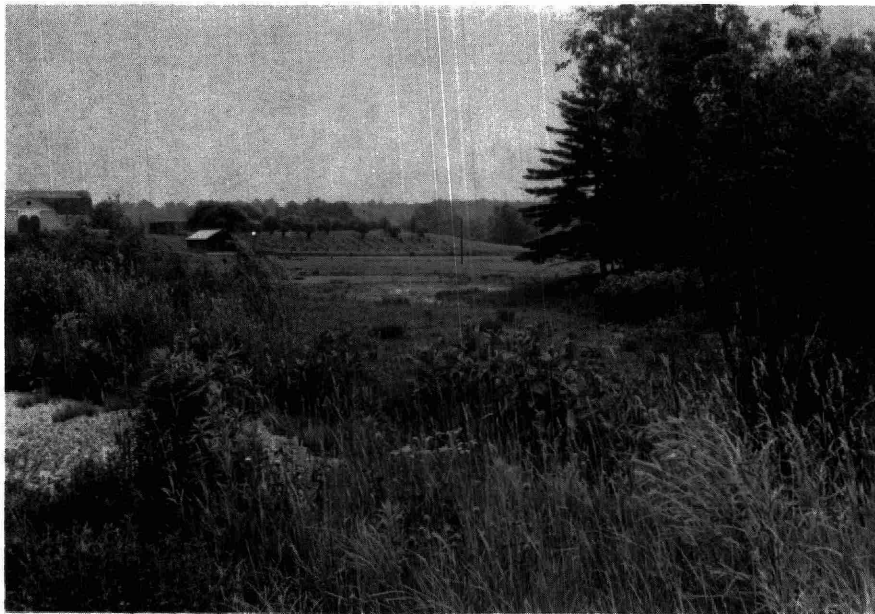
Looking downstream from the station. The creek flows at the right, hidden by the bush. The flood-plain is very susceptible to surface flooding. From the precipitation records, a significant amount of rainfall had occurred during the two-week period prior to the photograph. The flat topography and poor drainage characteristics are evident throughout the channel portion of the downstream area of the basin.

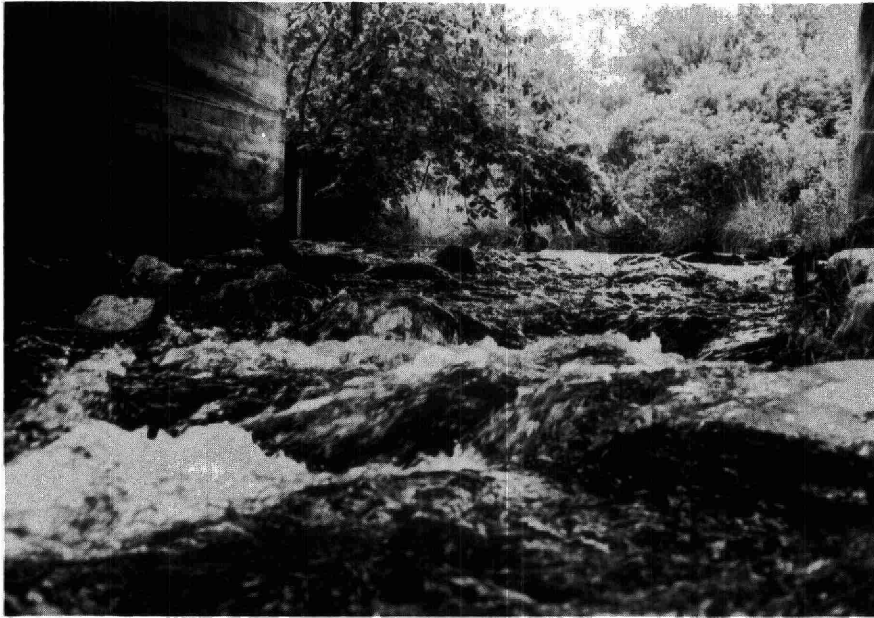
The change in streambed grade over the control creates high velocities and white-water turbulence. These points are visible in the photograph following.

Looking upstream over the control.
The staff gauge and pond appear in
the background.

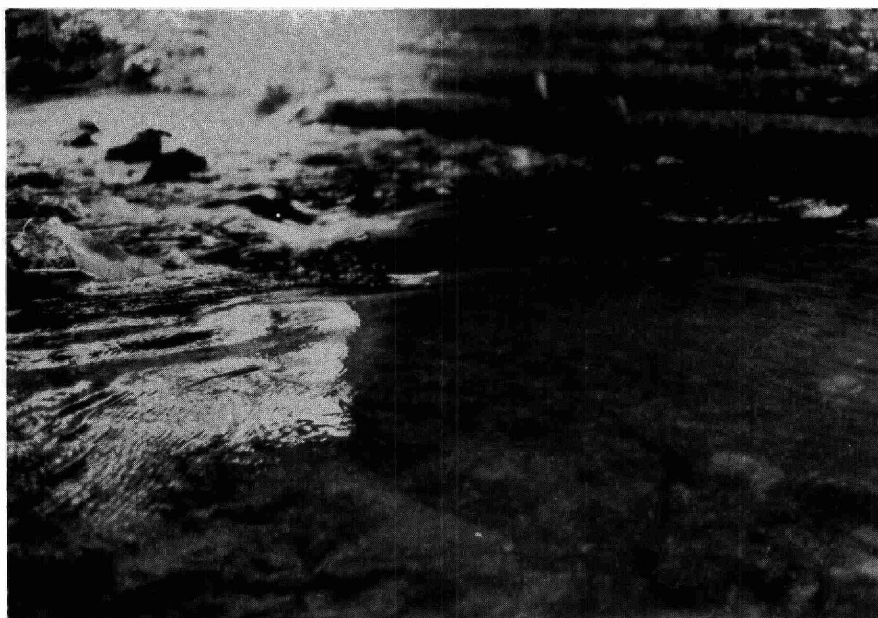
In the second photograph, the changes in
current pattern can be seen as the water flows over the
crest of the control.

Looking downstream over the control
from the pond.

Stage:	1.11 ft.
Discharge:	23.15 cfs
Average Velocity:	0.82 ft./sec.

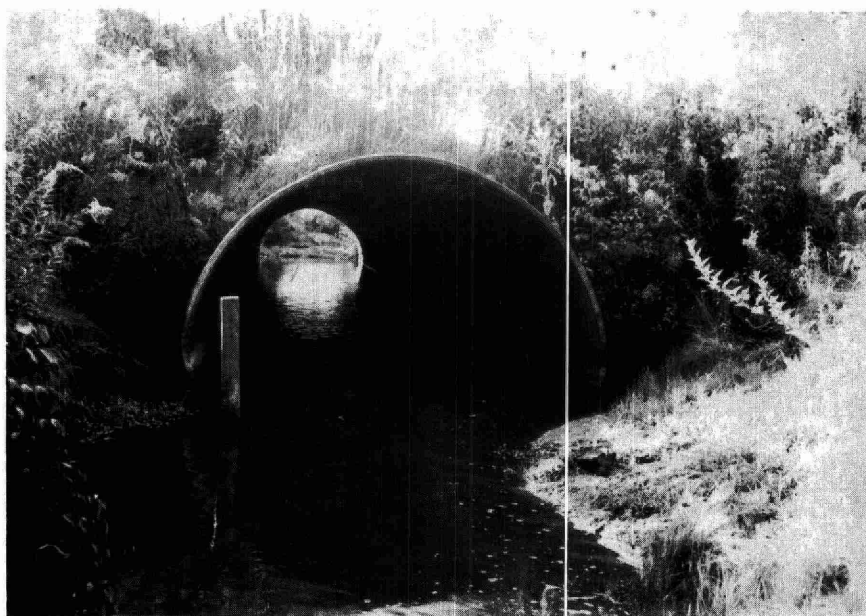
A series of photographs were taken at different times during 1969 to help establish the cause of the problem. The initial assumption was that the metal culvert was acting as the control; however, from the photographs, it would appear that the weed-bed at the downstream end of the culvert is influential as a control. As the water surface is almost level in the pond area upstream of the weeds, the weed-bed appears to have a controlling effect on the stage-discharge relationship.

Looking downstream through the culvert.
Staff gauge is in pond in the foreground.
Note the weed-bed downstream of the culvert.

5. A thorough attempt should be made to eliminate the plant growth at station V-2, so that a more reliable rating curve can be established and to determine whether or not the metal culvert can in itself act as a stable control.

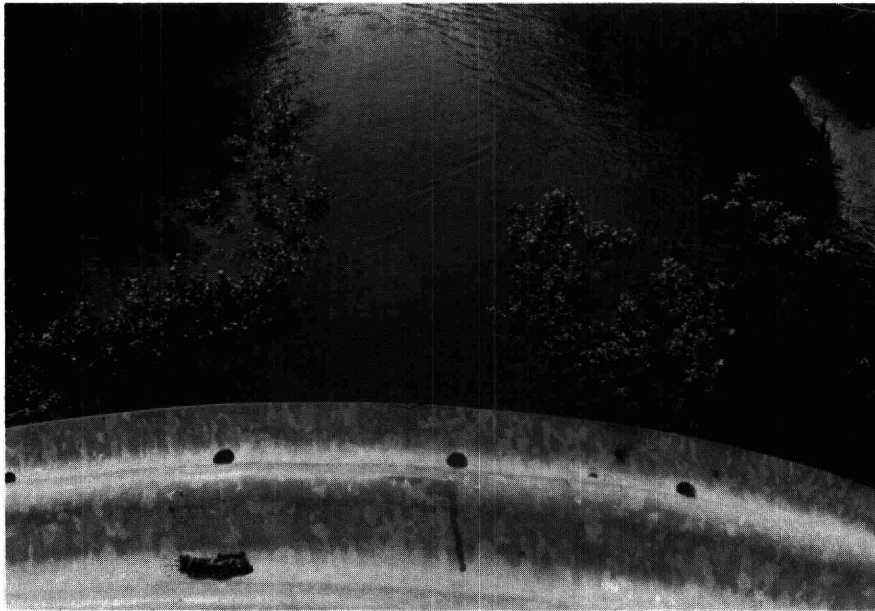
The effect of the weed-bed on the stage-discharge relationship can be verified by the following series of photographs taken at various times from June 30, 1969. The first was taken early in the growth period of the plant, the second and third at mid-season near full bloom, the fourth in the early fall, and the fifth in mid-January, 1970. The third photograph was taken from a different location to point out the massive and dense growth.

June 30, 1969.
Meter Point No. 44 on Figure 3.
Gauge Height = 736.37 ft.
Discharge = 5.44 cfs.

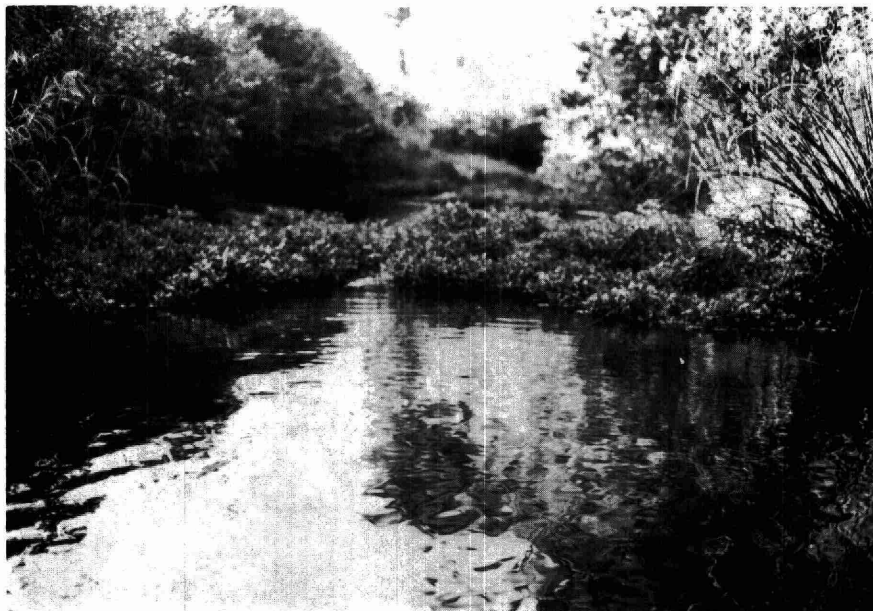
September 8, 1969.
Meter Point No. 46 on Figure 3.
Gauge Height = 736.14 ft.
Discharge = 2.72 cfs.

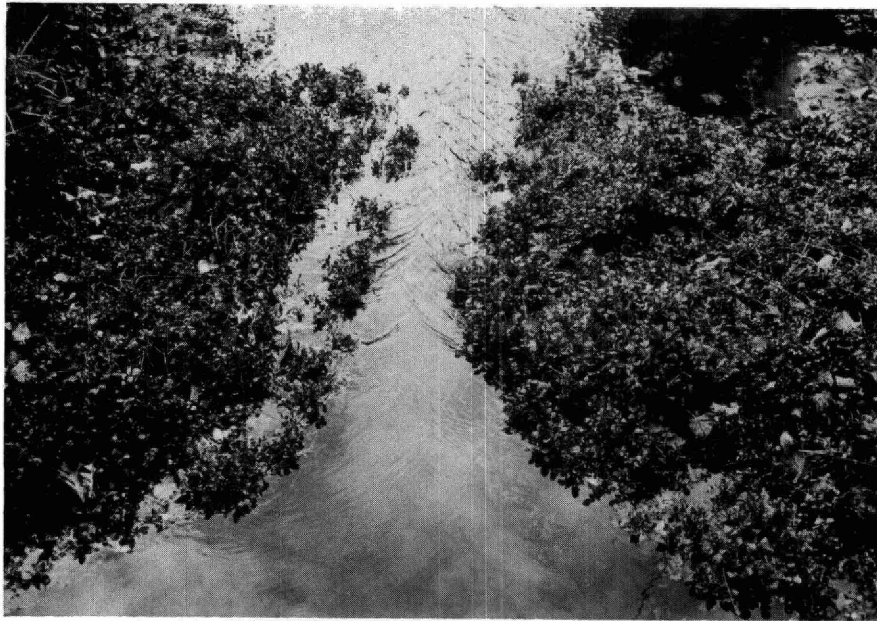
October 14, 1969.
Meter Point No. 47 on Figure 3.
Gauge Height = 736.15 ft.
Discharge = 2.50 cfs.

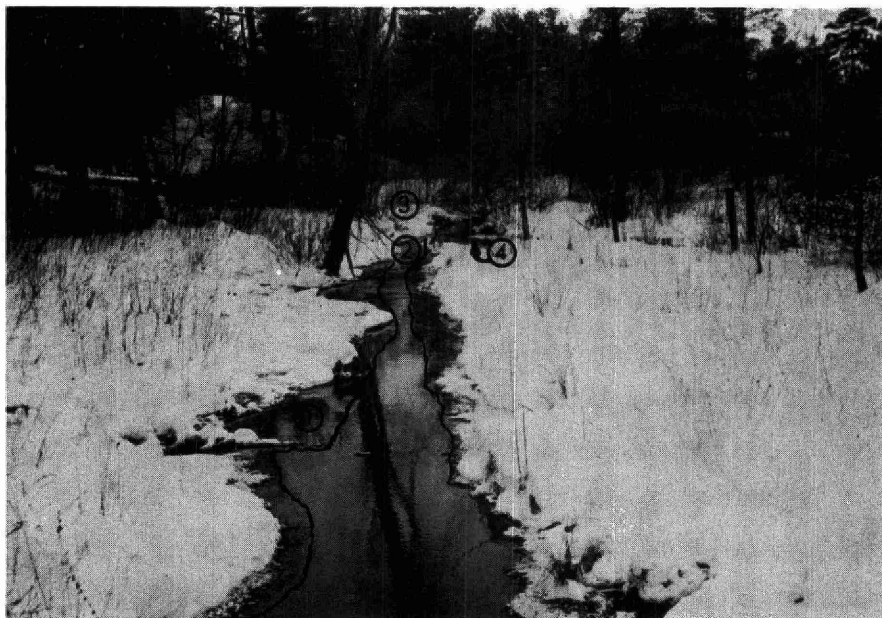
The following should be noted in the second photograph:

- (1) the darker areas in the water at points along the banks are plants (at this time of the year, the plants are at their lowest stage of growth),
- (2) the constriction in the channel starting approximately 60 feet downstream from the culvert and continuing beyond the fence,
- (3) the wire fence across the channel, and
- (4) the log caught to the right of the channel in the fence.

Looking downstream from the culvert.

8. The plant growth in the streambed at station V-3 should be observed for its backwater effect, especially during intermediate and high flows from September to April.
